Mission Success Bulletin

September 18, 2003

CAIB Issues Columbia Accident Report

Board gives "thumbs-up" to quality and workmanship at Michoud

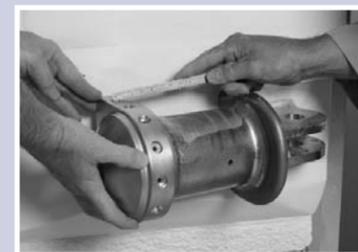
The redesigned bipod configuration

Last month, the Columbia Accident Investigation Board concluded that foam from the bipod area detached and impacted the shuttle's left wing during ascent and recommended an aggressive campaign to eliminate foam debris, particularly in the bipod area. The new design will eliminate the need for the foam ramp that was used to keep ice from forming on the bipod fitting prior to launch.

"We completed some critical development testing of the new design at the Marshall Space Flight Center during June, and have demonstrated that the heaters work in keeping ice off the fitting," Wallo said. "We repeated this testing at Eglin Air Force Base in July, finding some issues that we recently incorporated into the design. A retest is slated for the third week of September."

Wallo said the team also completed a structural capability test in Building 404 in early July that demonstrated that the new modifications did not affect the structural capability of the fitting.

"These tests prove the thermal concept works, and more importantly, that the redesign doesn't impact the structural integrity of the fitting." Verification tests for the bipod redesign are currently on schedule this month in several locations: a full-up structural test at Michoud, a thermal verification retest at Eglin AFB, Fla. and wind tunnel tests at the Arnold AFB Engineering Development Center, Tenn.

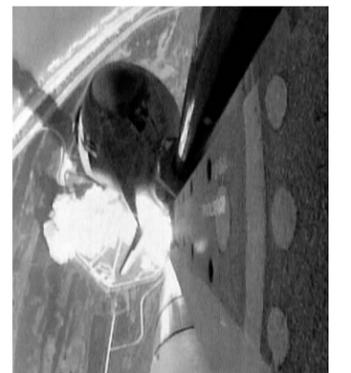
ET camera view on STS-112

The camera is eight inches long, two inches wide and two inches high and weighs less than a pound. Packaging is taking place at Johnson Space Center where qualification testing is scheduled later this month.

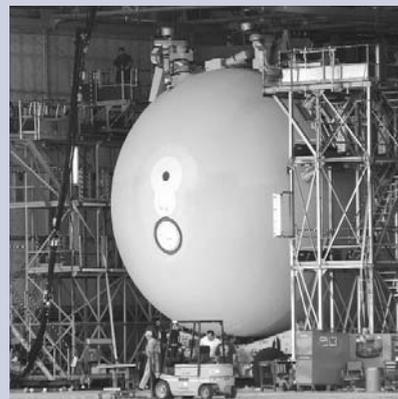
Bring 'Em On!

External Tanks are rolling into the two mod centers (Bldgs. 420 & 103) for critical retrofitting. Tanks from both Michoud and Kennedy Space Center will pass through the centers before returning to flight.

ET-120 is the first tank scheduled for retrofitting in Bldg 420, followed by ET-121 in Final Assembly. Three tanks, ET-117, ET-118 and ET-119, reside at Kennedy Space Center and are in the queue to return to Michoud pending schedule.
